RED RIVER FLOODWAY INLET CONTROL STRUCTURE 1997 FLOOD DAMAGE TO DOWNSTREAM RIPRAP APRON REPORT

March 16, 1999

RE: Project 1653-C Remediation of the Downstream Riprap Apron
Red River Floodway Inlet Control Structure

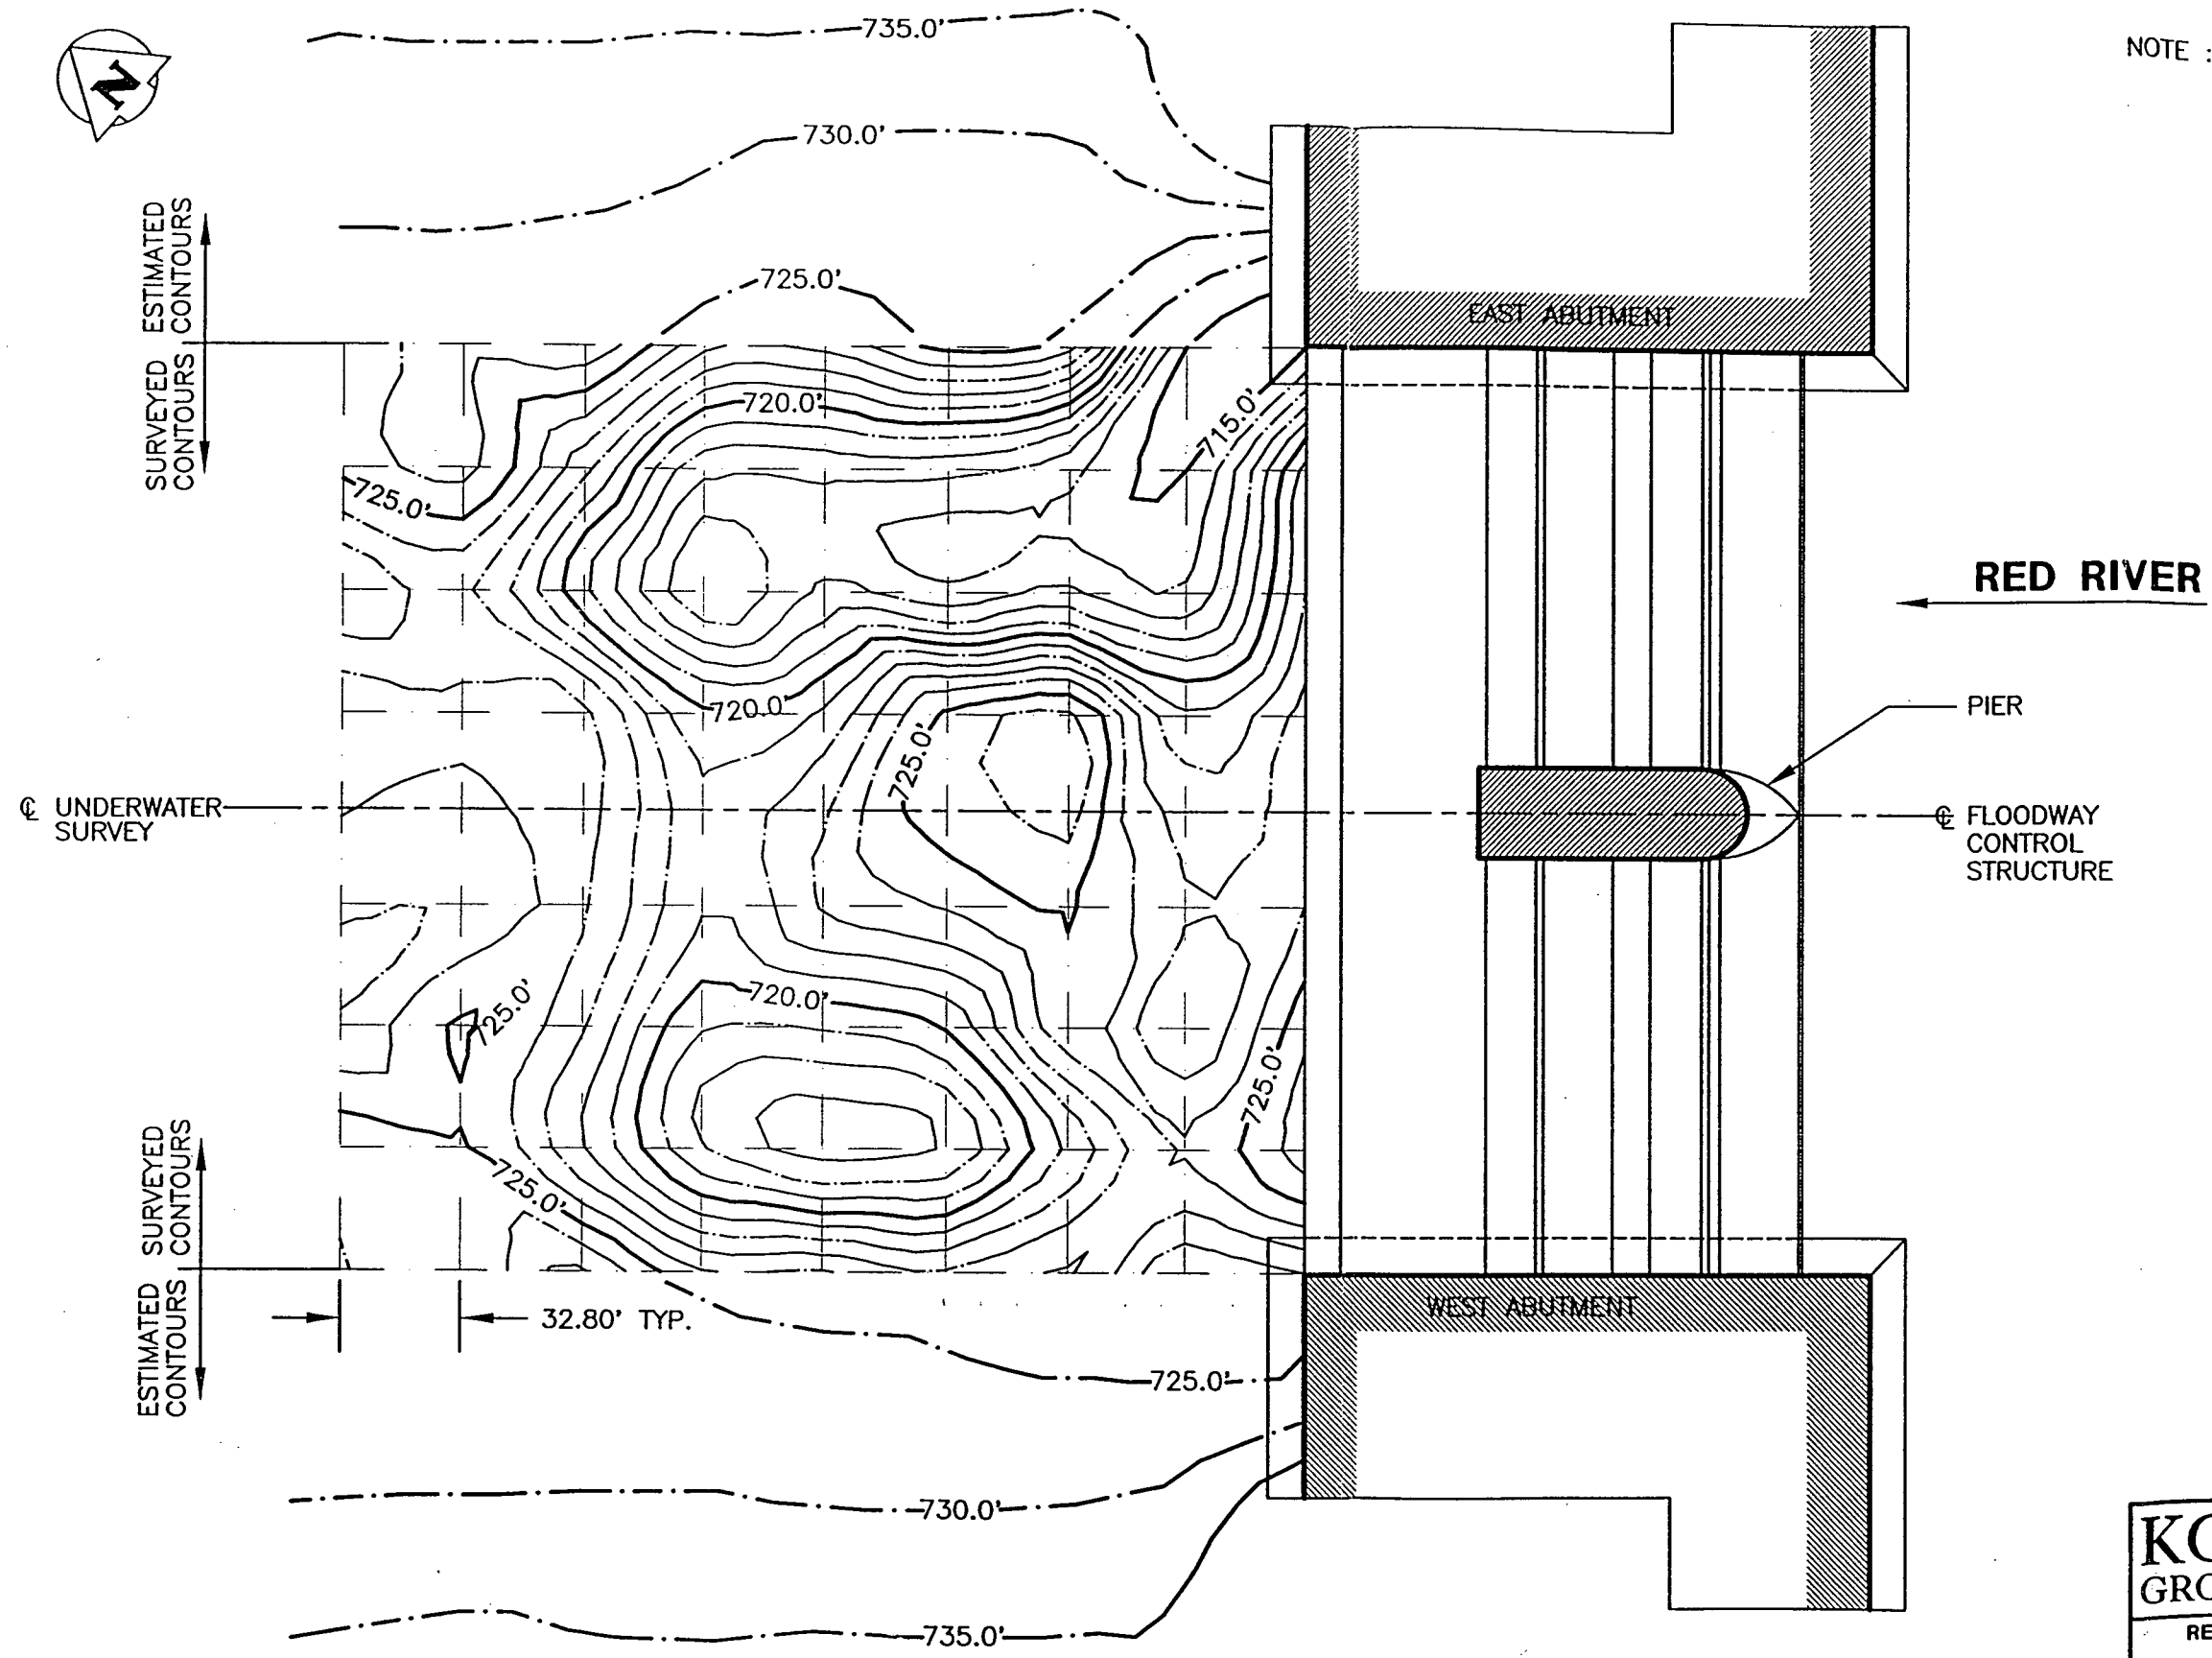
KGS GROUP	MANITOBA DEPARTMENT OF NATURAL RESOURCES
	RED RIVER FLOODWAY - INLET CENTRAL STRUCTURE EROSION STUDY
EROSION DOWNSTREAM & INLET STRUCTURE - 1995	
AUGUST 1995	FIGURE 5.1

A comparison of the pre and post 1997 flood surveys was performed. Contour diagrams of each survey are shown in Figures 1 and 2. From the contour diagrams, nine profiles were derived and are illustrated on the attached profile Figures 3 to 13.

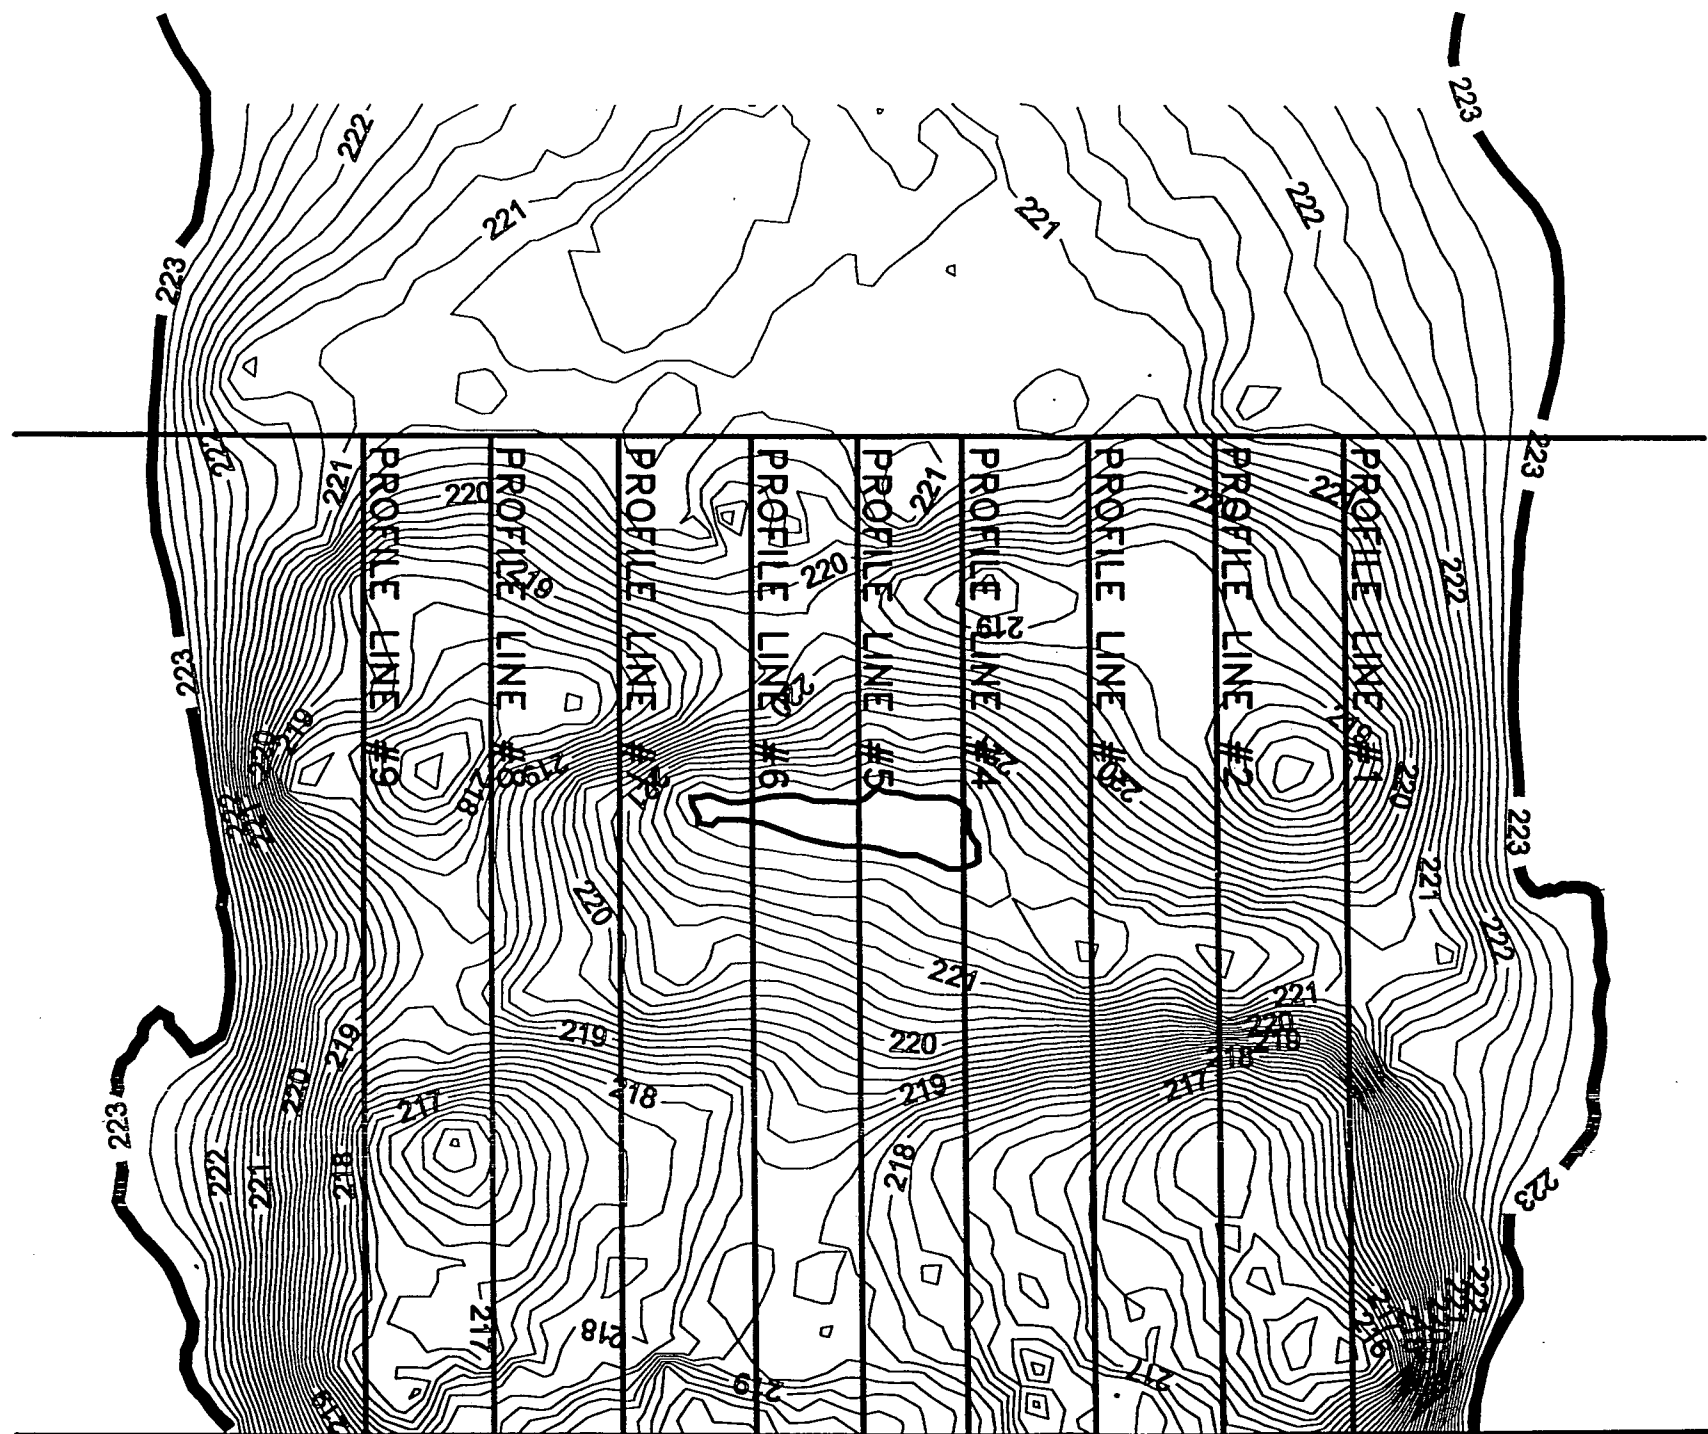
RED RIVER FLOODWAY INLET CONTROL STRUCTURE EROSION ASSESSMENT	
RED RIVER FLOODWAY INLET CONTROL STRUCTURE - DOWNSTREAM RIVERBED CONTOUR PLAN (1998)		
07/98		FIGURE 5.1

It can be determined from the profile figures that the 1997 flood significantly changed the bed profile downstream of the structure. In general, additional scour of 1.5 to 2 metres was experienced directly adjacent to the structure sill, and the material scoured was pushed and deposited downstream approximately 30 to 40 metres. The deposition area increased elevation from 1995 by up to 3 metres. The mounding was most evident near the middle of the channel, and the greatest scour occurred near the abutments further undermining the wing wall embankments.
