RED RIVER FLOODWAY INLET CONTROL STRUCTURE 1997 FLOOD DAMAGE TO DOWNSTREAM RIPRAP APRON REPORT

March 16, 1999

File No. 99-311-01

RE: Project 1653-C Remediation of the Downstream Riprap Apron
Red River Floodway Inlet Control Structure

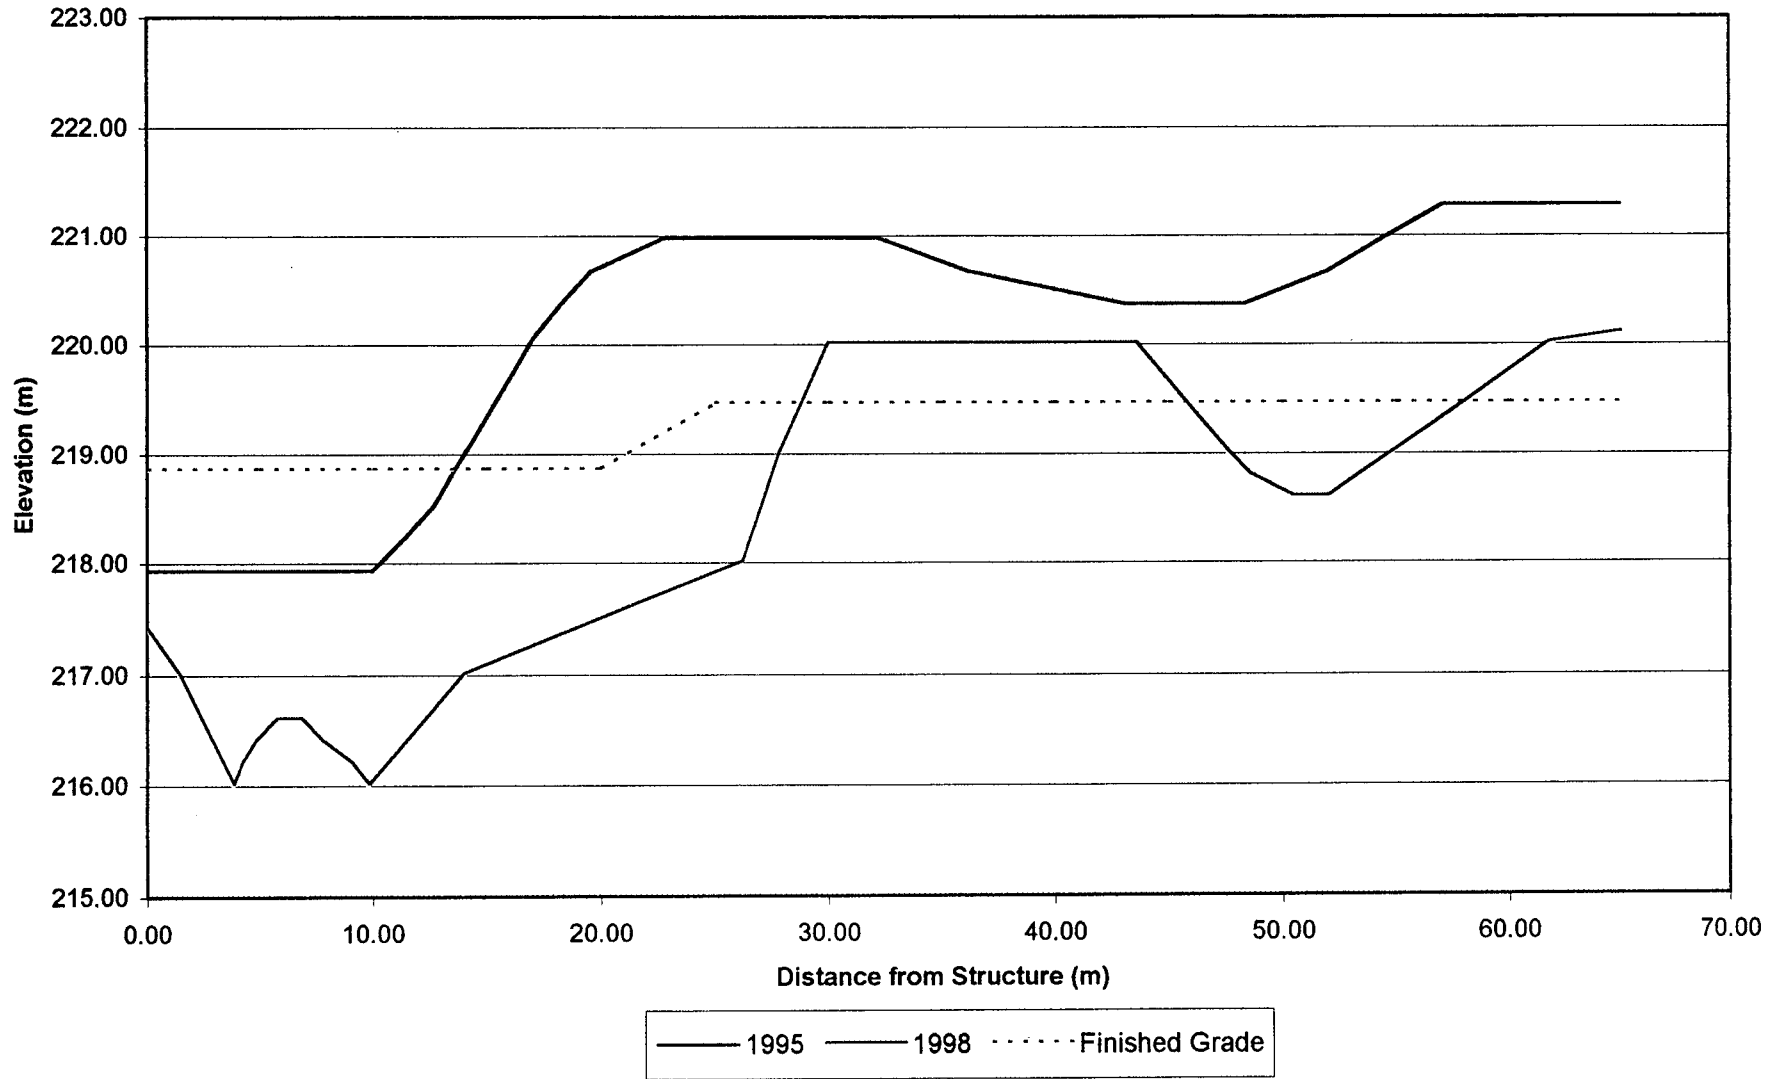
Profile # 1

It can be determined from the profile figures that the 1997 flood significantly changed the bed profile downstream of the structure. In general, additional scour of 1.5 to 2 metres was experienced directly adjacent to the structure sill, and the material scoured was pushed and deposited downstream approximately 30 to 40 metres. The deposition area increased elevation from 1995 by up to 3 metres. The mounding was most evident near the middle of the channel, and the greatest scour occurred near the abutments further undermining the wing wall embankments.
