MANITOBA FLOODWAY AUTHORITY

RED RIVER FLOODWAY EXPANSION PROJECT
2006 GROUNDWATER MONITORING ACTIVITY REPORT
FINAL REPORT
MARCH, 2007

KGS Group Project: 05-1100-01.19.12.06
Reference Number: .9905212 HM29

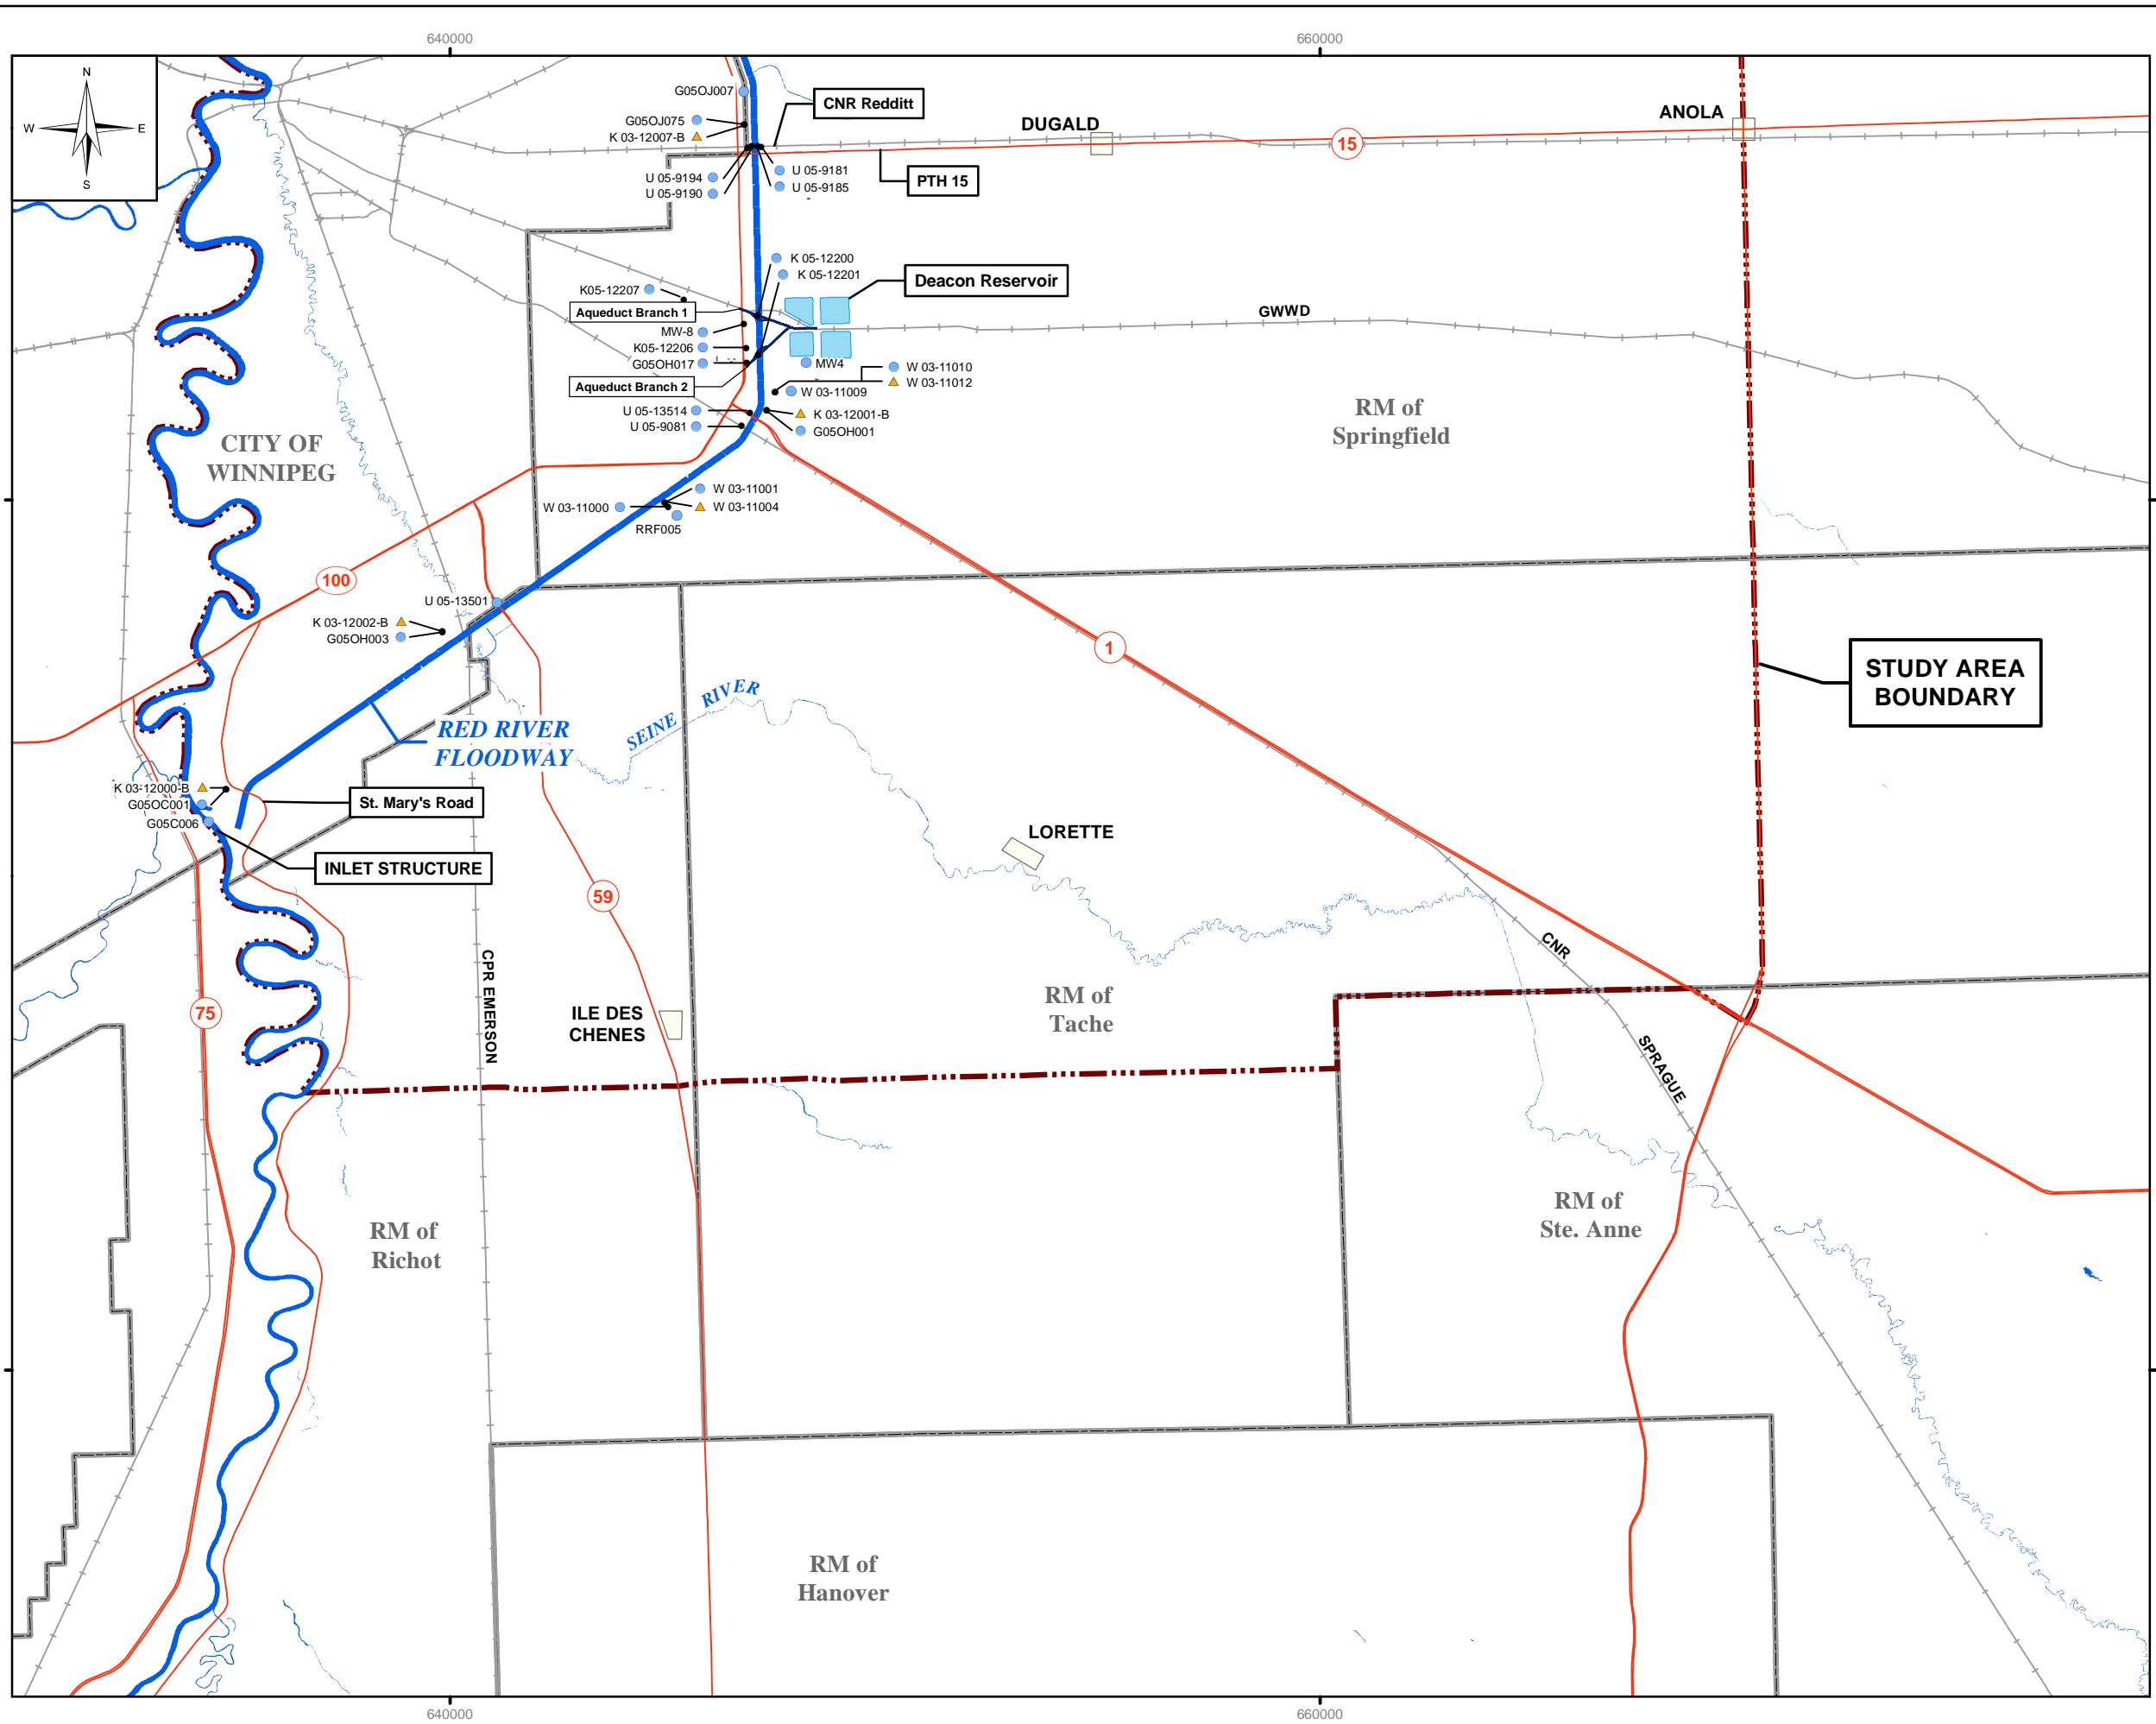
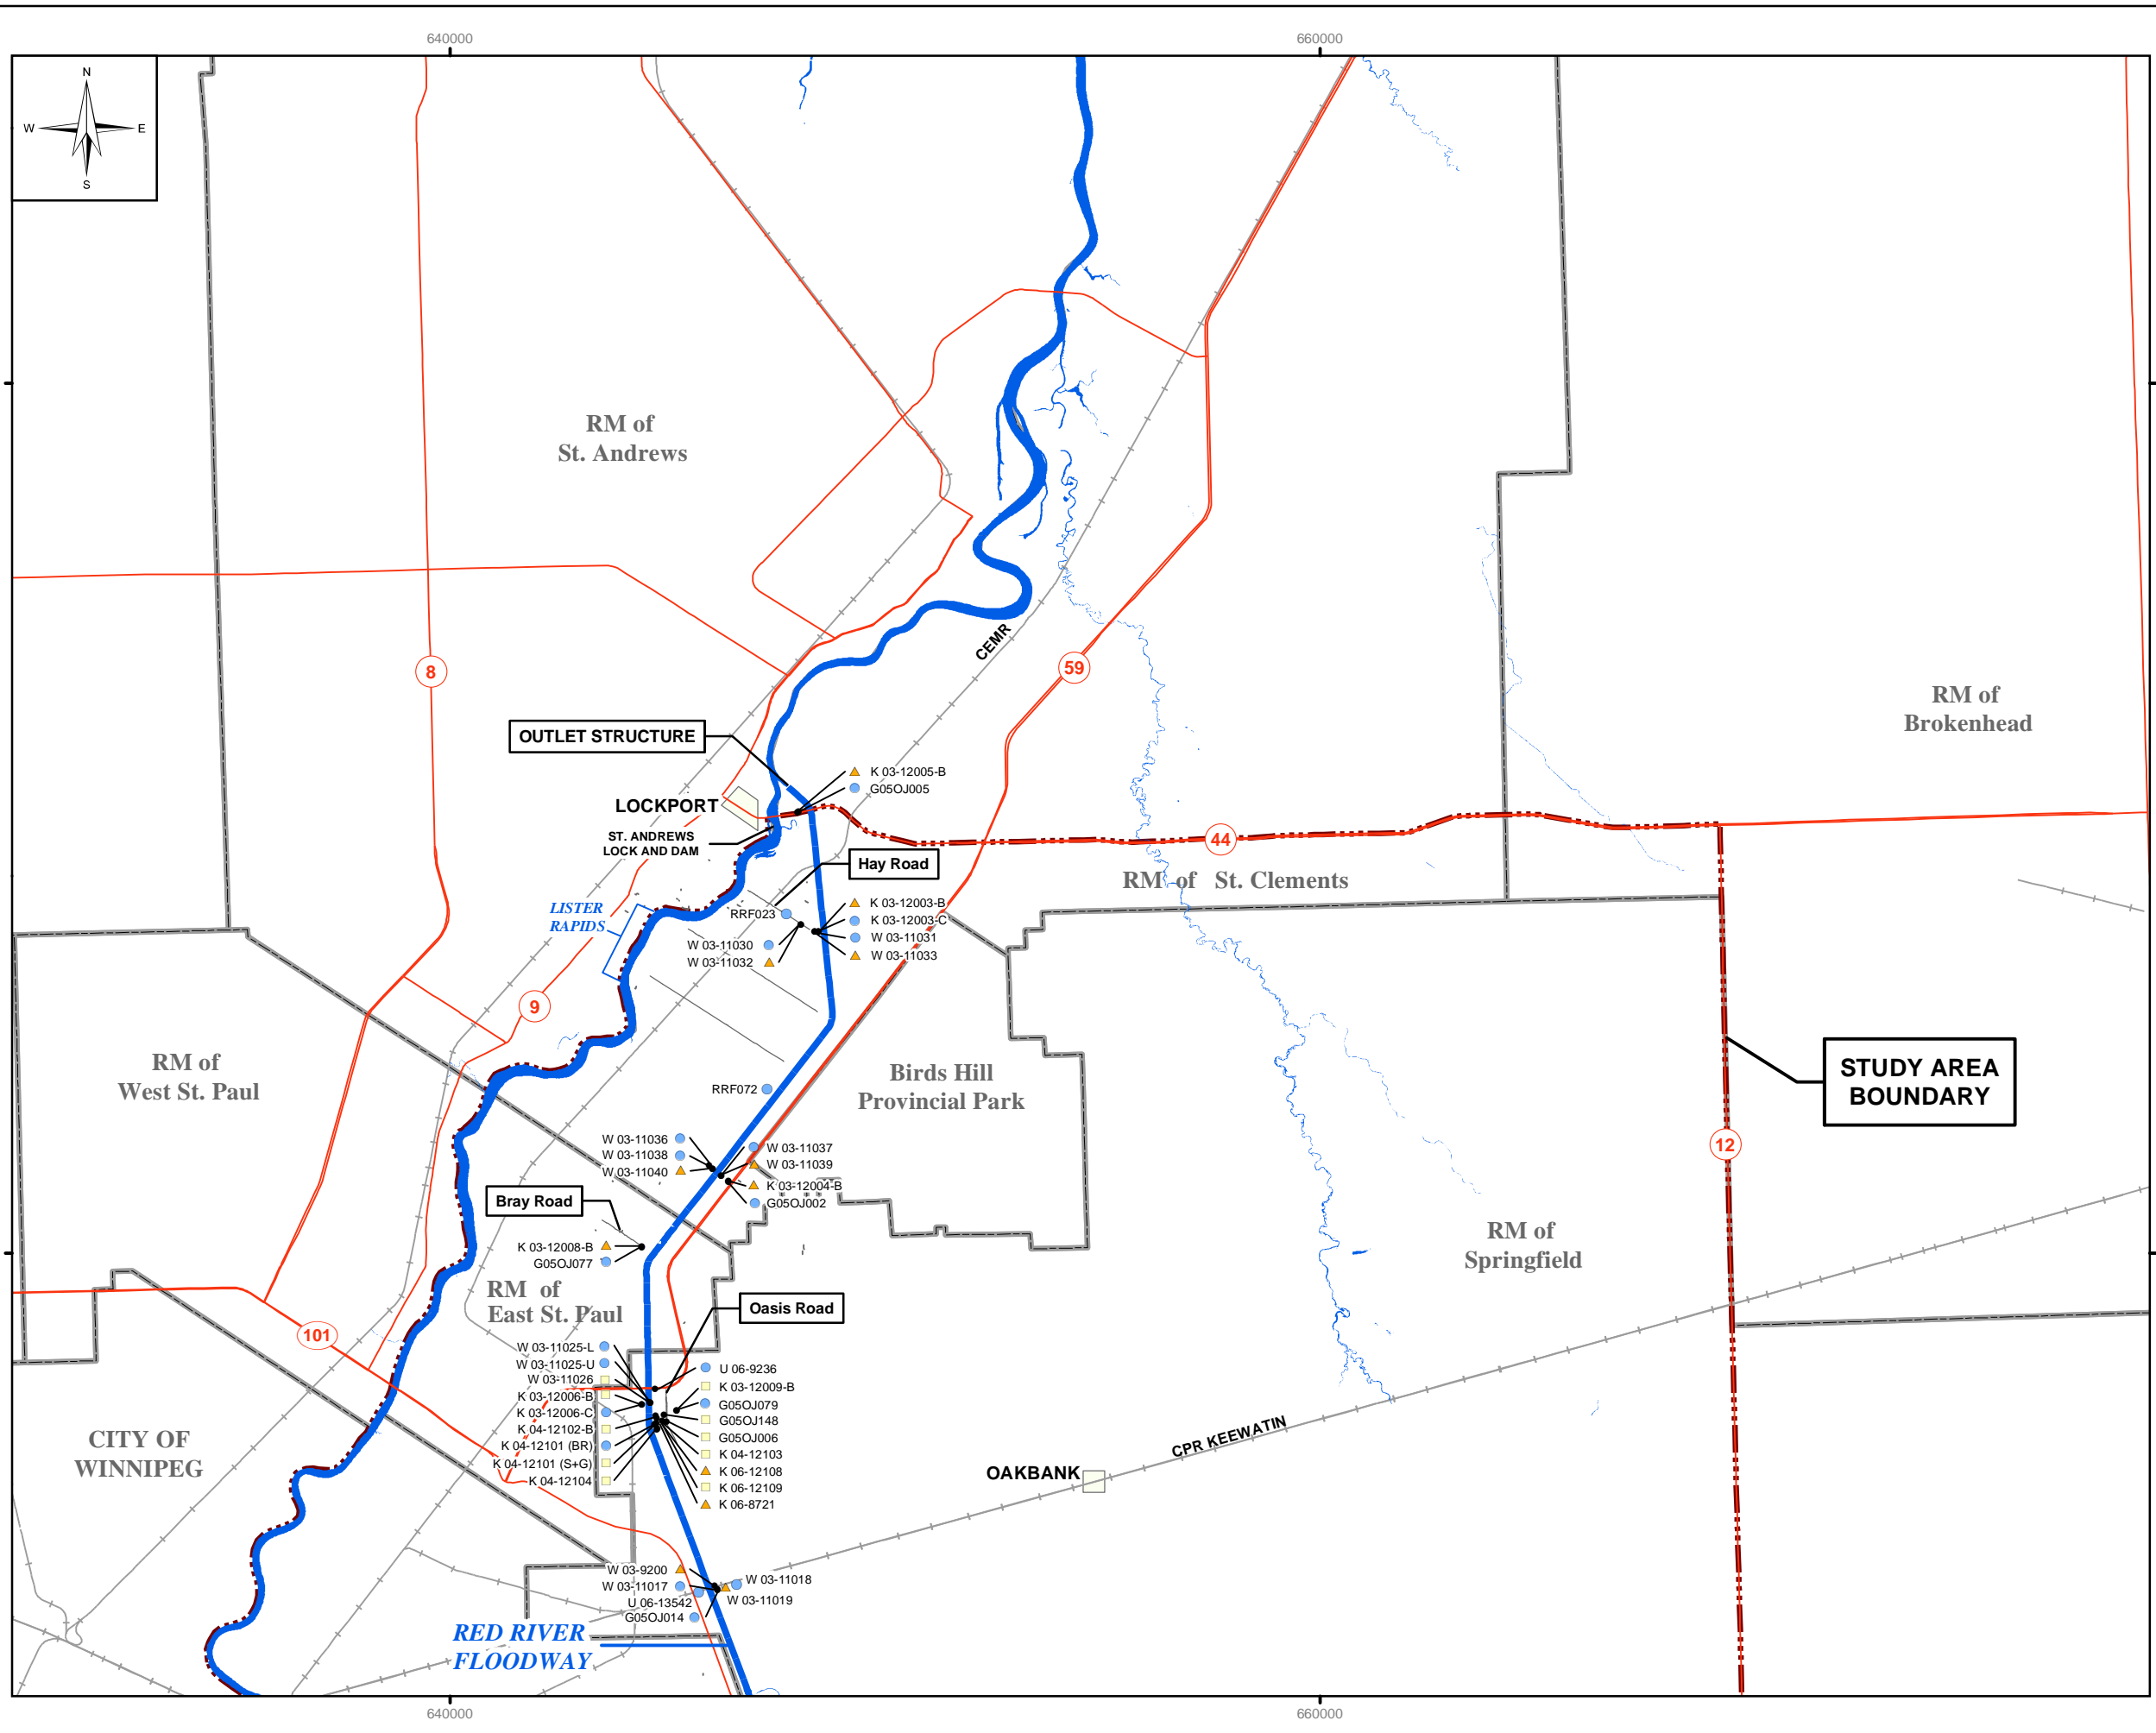
Monitoring well samples have been collected from approximately 38 bedrock wells, 20 till wells, and 6 sand and gravel wells (Oasis Road area only), adjacent to the Floodway. Monitoring well locations are shown in Figure HM29-2. Conductivity in the monitoring wells generally shows the same distribution along the Floodway as for the domestic wells.
